Inspection reference: 112124MG1

Confidential Inspection Report

November 21, 2024

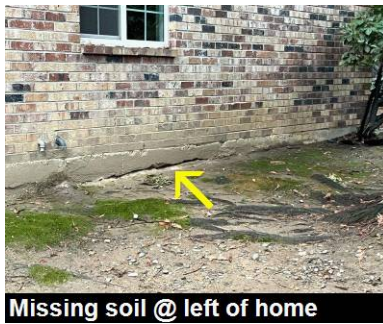
[CR] There were areas (left side) of the foundation that were undermined and lacking the support of the soil, this should be corrected to prevent damage to the foundation.

Missing soil @ left of home

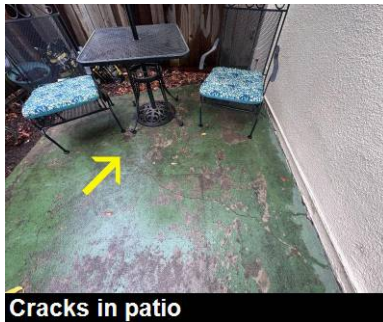
GOOD	FAIR	POOR	FAIL	
2105 WALKWAY(S)	<input checked="" type="checkbox"/>	<input type="checkbox"/>	<input type="checkbox"/>	<input type="checkbox"/>	[NOTE] There are municipalities that may not be financially responsible for the cost of repairs to city/county sidewalks that pass through private property and that have become potential safety hazards. There are sections of walkways that appeared functional.
2106 STEP(S)	<input checked="" type="checkbox"/>	<input type="checkbox"/>	<input type="checkbox"/>	<input type="checkbox"/>	There are steps that are visibly intact.
2107 MAIN ENTRY	<input checked="" type="checkbox"/>	<input type="checkbox"/>	<input type="checkbox"/>	<input type="checkbox"/>	The entry(s) appeared functional, not fully observable due to stored items [NOTE] Common cracks are present, as long as these cracks do not present trip hazards they are mainly a cosmetic issue.
2109 PATIO(S)/LANDING(S)	<input type="checkbox"/>	<input checked="" type="checkbox"/>	<input type="checkbox"/>	<input type="checkbox"/>	There were patio(s)/landing(s) that were visually intact, not fully observable due to debris/stored items, with exceptions. [CR] There are cracks in the patio, these should be sealed to prevent further water intrusion and potential displacement.

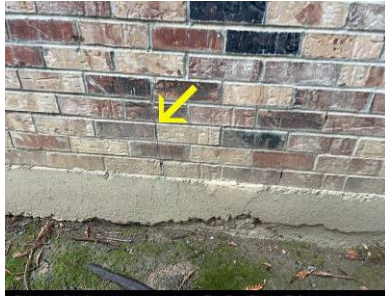
[CR] There was visible veneer materials that had cracks, this can allow for moisture intrusion and hidden damage.

Crack in veneer @ left of home

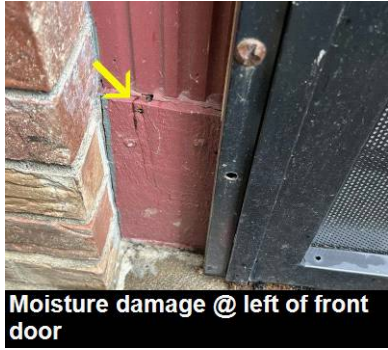
[FE] The exterior wood trim has moisture damage/deterioration at front of the building, there may be further hidden damage. These conditions are conducive to moisture intrusion/deterioration and wood destroying organism infestation/decay, additional information may be available in the Pest Report.

Moisture damage @ left of front door

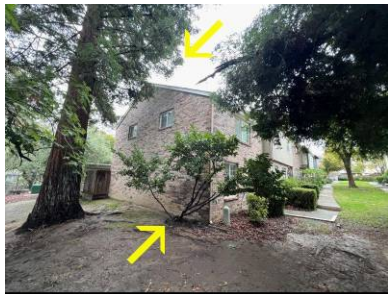
GOOD	FAIR	POOR	FAIL	
2312 EAVE(S)/SOFFIT(S)	<input checked="" type="checkbox"/>	<input type="checkbox"/>	<input type="checkbox"/>	<input type="checkbox"/>	There are eave and soffit materials that were visibly intact [FE] <u>There are eaves that are sealed/paneled over and the rafter tails and sheathing can not be inspected. Often this is considered a cosmetic improvement but this can also hide defects. Removal for inspection can be cost prohibitive and may be unnecessary.</u>
2313 FASCIA(S)/BARGE RAFTERS	<input checked="" type="checkbox"/>	<input type="checkbox"/>	<input type="checkbox"/>	<input type="checkbox"/>	There are barge rafter and/or fascia materials that were visibly intact.
2314 RAFTER TAILS/CORBELS	<input type="checkbox"/>	<input type="checkbox"/>	<input type="checkbox"/>	<input type="checkbox"/>	There are rafter tails not visible due to sealed eaves.
2315 LANDSCAPING	<input type="checkbox"/>	<input type="checkbox"/>	<input checked="" type="checkbox"/>	<input type="checkbox"/>	[CR] <u>There are areas of the property where maintenance, trimming or removal of vegetation is needed to prevent and/or remove overgrowth and encroachment onto the building. This allows the exterior siding to dry after getting wet, prevents deterioration by brush rubbing against the siding and discourages against nesting areas for rodents and pests.</u> [CR] <u>Trees are that are too close to the home and/or touching or over-hanging the roof, as trees continue to grow in size, damage may occur to the roof, foundation and/or structure. The trees should be trimmed to prevent debris and damage to the roofing surface and allow free flow of roof runoff. Consideration should also be given to removal of the trees to prevent potential damage to the foundation and/or structure.</u>

Tree & plant too close to home

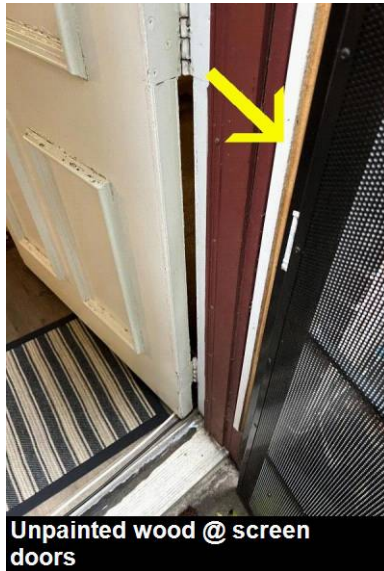
[CR] There were exterior doors that have loose, deteriorated and/or missing paint/finish and/or caulking. This condition can allow pest and moisture intrusion and damage.

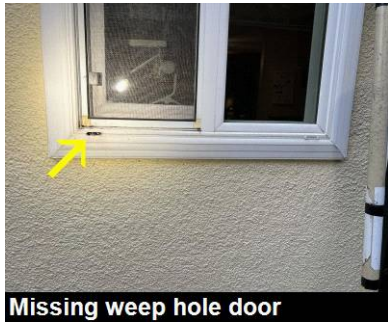
[CR] There are window(s) (various) that have damaged weep holes, this condition can prevent the frames from draining water and can create noise during wind events. All windows and sliding doors be examined and returned to functioning condition if found deficient.

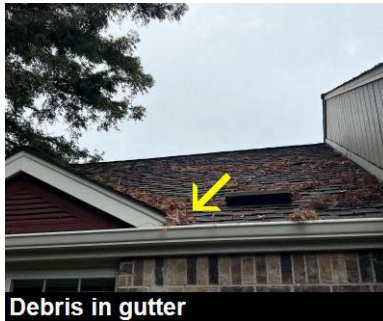
[CR] There were observable gutters that contain debris, this inhibits correct operation of the gutters and should be corrected.

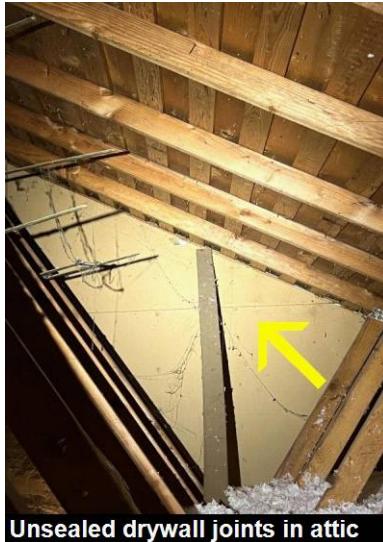
[SC] There are holes/openings/unsealed joints in what appeared to be a fire or party separation wall in the attic.

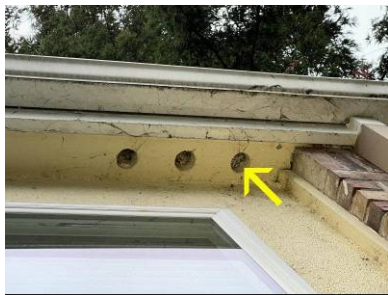
[CR] There are attic vents that have been blocked/painted and/or dirty with built-up debris, reducing the ventilation. This condition is conducive to moisture build-up in the winter and excess heat build-up in the summer.

Paint & debris @ soffit vents

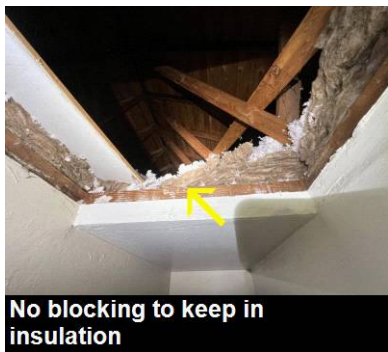
[CR] There were attic hatches where the insulation is not blocked away from the opening. It is not possible to remove the hatch without insulation falling to the ground.

No blocking to keep in insulation

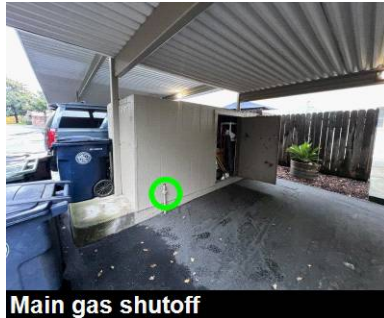
5001 GAS SHUTOFF

The gas meter(s) and shutoff valve(s) are located at the rear of the building.

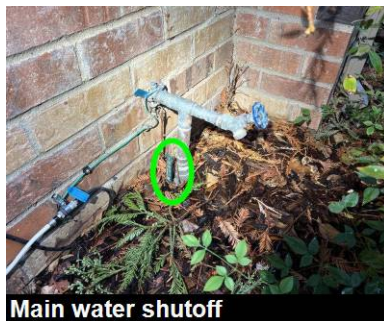
5003 WATER SHUTOFF

The main water shutoff valve(s) appears to be located at the front of the building.

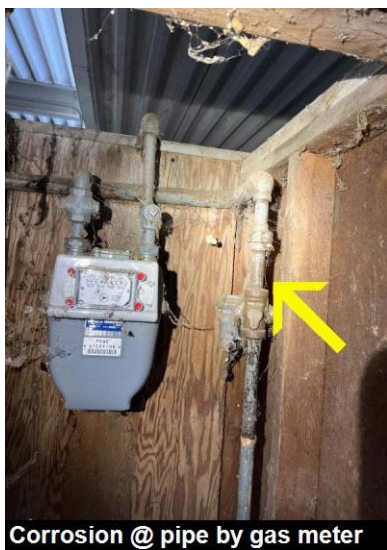
GOOD	FAIR	POOR	FAIL	
5100 GAS SHUTOFF	<input type="checkbox"/>	<input type="checkbox"/>	<input type="checkbox"/>	<input type="checkbox"/>	The supply shutoff was visibly intact, we do not operate these devices [RU] There is no emergency shutoff wrench present. We recommend providing a wrench or installing a seismic automatic shut off valve for emergencies. Some jurisdictions require the installation of an automatic shut off valve upon resale. We do not know if this jurisdiction requires such a mandate.
5102 GAS PIPING	<input type="checkbox"/>	<input checked="" type="checkbox"/>	<input type="checkbox"/>	<input type="checkbox"/>	There are observed areas of the gas piping that was visibly intact, with exceptions. <u>[SC] There are areas (by meter / main shutoff) of the observed gas piping that have corrosion. This can lead to pipe failure and gas leakage, this is a safety hazard.</u>

Corrosion @ pipe by gas meter

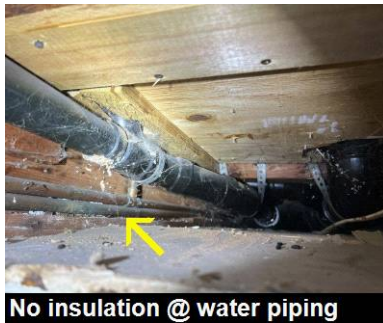
GOOD	FAIR	POOR	FAIL	
5111 WATER SHUTOFF	<input type="checkbox"/>	<input type="checkbox"/>	<input type="checkbox"/>	<input type="checkbox"/>	The observed main water shutoff valve(s) was visibly intact (we do not operate these devices)
5112 WATER PIPING	<input type="checkbox"/>	<input checked="" type="checkbox"/>	<input type="checkbox"/>	<input type="checkbox"/>	There were observable areas of water supply piping that were visibly intact, with exceptions <u>[CR] There are un-insulated hot water supply pipes.</u> <u>[SC] There are un-insulated exterior water supply pipes. All exposed water supply pipes should be insulated to help protect against bursting pipes from freeze events and minimize water temps over 125 degrees during extreme heat events which is a safety hazard.</u>

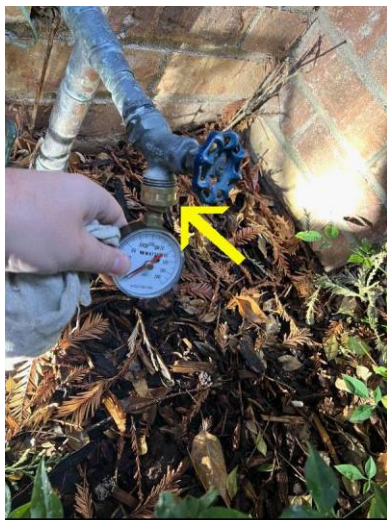
[CR] There are hose faucet(s) (front) that have damaged threads and hoses and accessories may not attach correctly or at all.

Bad threads @ front hose faucet

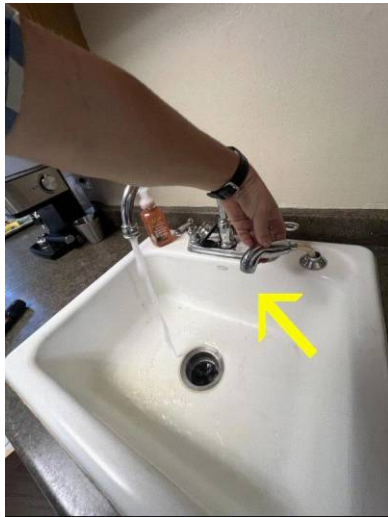
[CR] There were sinks (kitchen) where the hand sprayer was not functioning

Kitchen sprayer not working

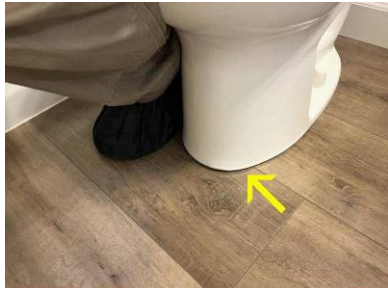
[CR] There were toilets that are loose on the floor (both). This is conducive to moisture intrusion and damage into concealed spaces and should be corrected and recaulked to the floor.

Loose toilets in home

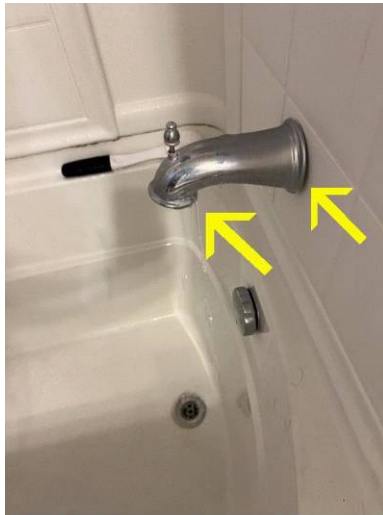
[CR] There are tub-to-shower diverter(s) that failed to fully divert the water flow to/from the showerhead.

Leaking diverter & missing caulking

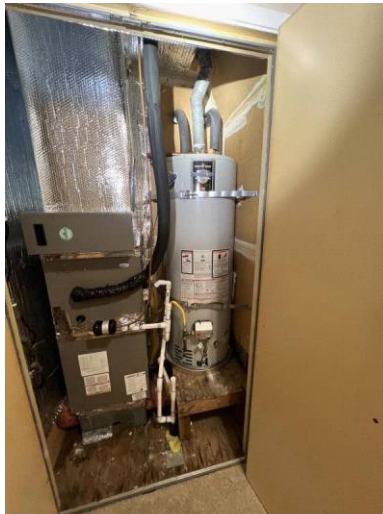
The water heater was located in an interior utility closet.

Water heater @ upper hall closet

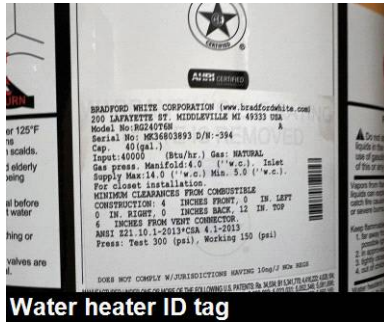
Bradford White.

Water heater ID tag

- 5302 MANUFACTURE DATE 2015 based on the ID tag information.
- 5303 SIZE / GALLONS 40 gallon based on the ID tag information.
- 5304 ENERGY TYPE(S) Gas.

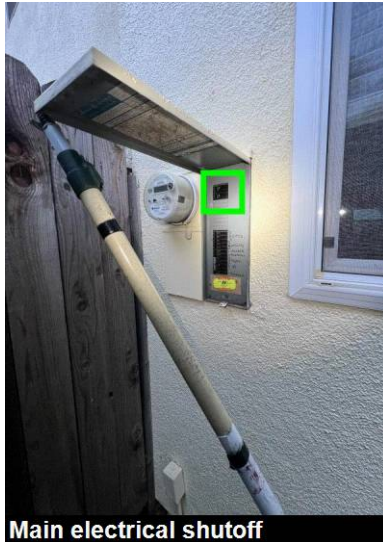
6001 SERVICE TYPE Underground.
 6003 MAIN PANEL(S) Located at the rear of the building.

Main electrical shutoff

6004 SERVICE RATING 120/240 volt, single phase system, rated at 100 Amperes.
 6005 SERVICE WIRING Not observable in the main panel.
 6006 CIRCUIT WIRING Materials: copper and aluminum, where visible.
 6007 DISCONNECT TYPE Circuit breakers

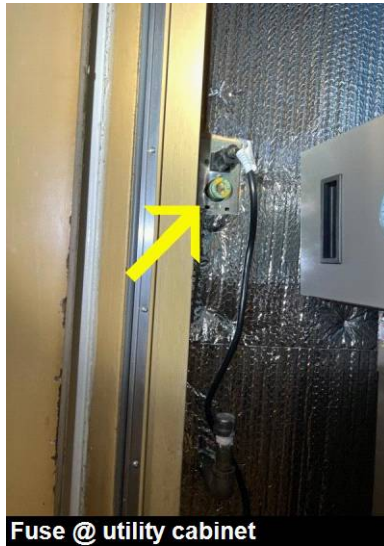
[FE] There are old and outdated electrical systems in the home, it was not confirmed that these systems were disconnected or if they were still in use. We recommend a thorough examination with costs to remediate by a professional, licensed electrician.

Fuse @ utility cabinet

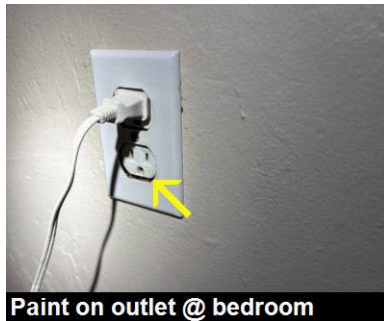
GOOD	FAIR	POOR	FAIL	
6310 DOOR BELL(S)	<input type="checkbox"/>	<input type="checkbox"/>	<input type="checkbox"/>	<input type="checkbox"/>	There were no visible door bell(s) installed.
6311 SWITCHES	<input checked="" type="checkbox"/>	<input type="checkbox"/>	<input type="checkbox"/>	<input type="checkbox"/>	There were accessible switches that were visibly intact and functional.
6314 GROUNDED RECEPTACLES [OUTLETS]	<input type="checkbox"/>	<input checked="" type="checkbox"/>	<input type="checkbox"/>	<input type="checkbox"/>	There were accessible receptacles (outlets) that are visibly intact and functional, with exceptions. <u>[SC] There were receptacles that are painted, this is a fire hazard.</u>

Paint on outlet @ bedroom

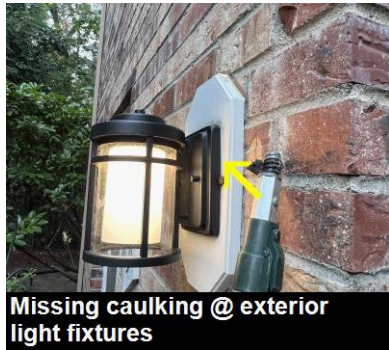
6315 LUMINARIES [LIGHTS/FIXTURES]	<input type="checkbox"/>	<input checked="" type="checkbox"/>	<input type="checkbox"/>	<input type="checkbox"/>	There are luminaries [lights] that are visible intact and functional, with exceptions. <u>[SC] There were exterior luminaries [light] fixtures that are missing caulking and can allow water to come in contact with electrical connections, this is a safety hazard.</u>
-----------------------------------	--------------------------	-------------------------------------	--------------------------	--------------------------	---

9. [SC] There were exterior luminaries [light] fixtures that are missing caulking and can allow water to come in contact with electrical connections, this is a safety hazard.

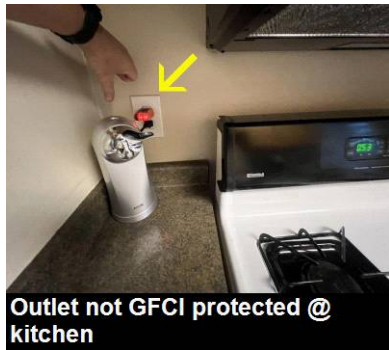
[SC] There are areas that are missing GFCI protected receptacles/outlets that are required with current construction/remodels. We recommend inquiring with the seller and if not installed, providing proper GFCI protection at locations where currently required: kitchen and laundry.

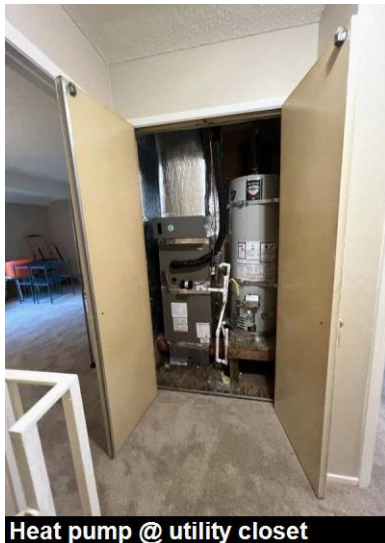
The heat is provided by a heat pump. A heat pump is the process of running your air conditioner in reverse. The heat pump/air conditioner equipment is located at the rear exterior of the home and an interior utility closet of the building.

Heat pump @ utility closet
 Advanced Distributor Products.

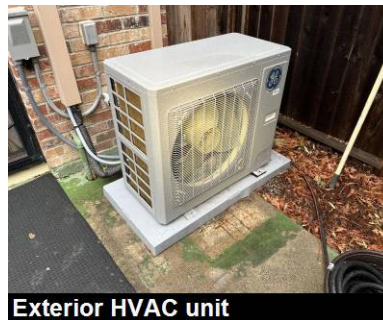
The compressor and condenser unit is located at the rear of the building.

Exterior HVAC unit

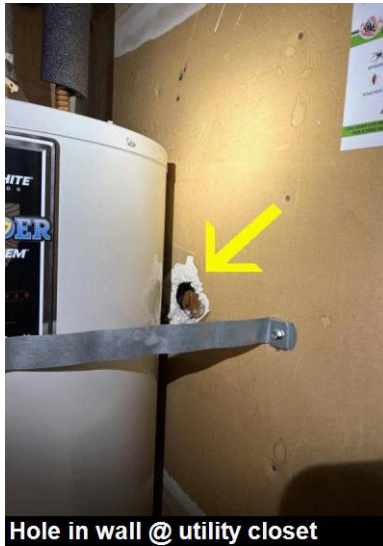
[FE] There is wall and/or ceiling material that may contain asbestos or asbestos like material. This can be a safety hazard if disturbed or when it is time for disposal. Recommend professional remediation for full evaluation and costs to correct.

Hole in wall @ utility closet

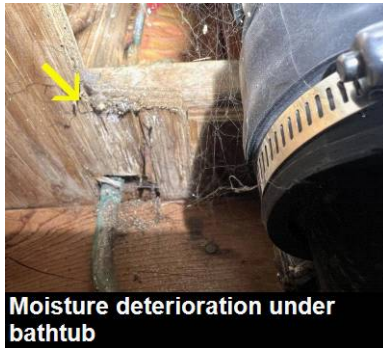
[FE] There is moisture-related stains and/or deterioration/damage on the interior subfloor under upper hall bath (viewed from access hatch). Note that hidden damage may exist and more investigation is necessary to determine the extent of damage. These conditions are conducive to moisture intrusion/deterioration and wood destroying organism infestation/decay, additional information may be available in the Home Pest Report.

Moisture deterioration under bathtub

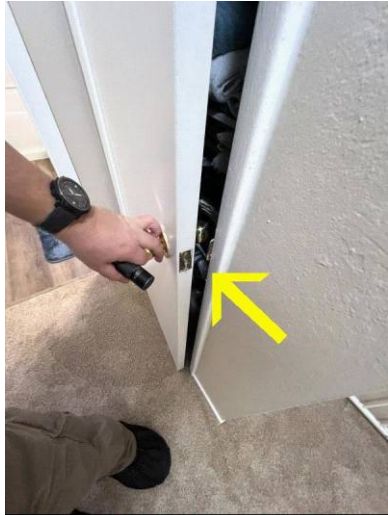
[CR] There were closet door(s) that did not latch to the jamb.

Upper hall closet door does not latch

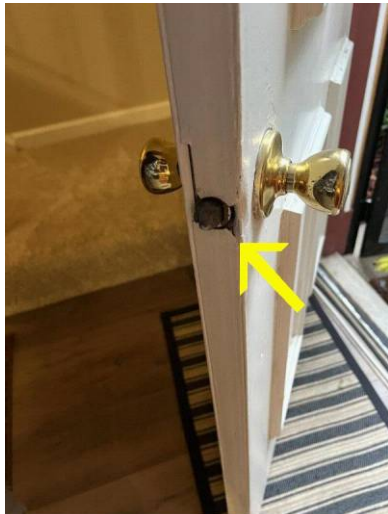
[SC] There are exterior door(s) with damage at entry. The safety/security of the door(s) may be compromised.

Damage @ entry door

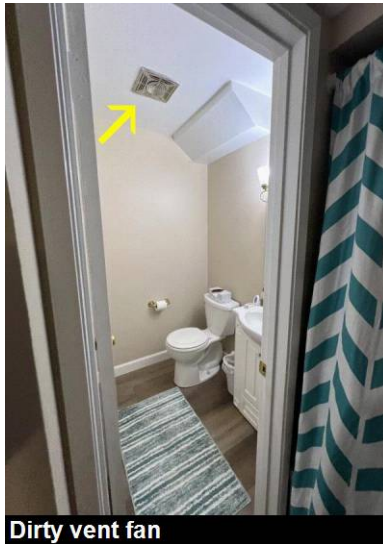
8201 INTERIOR DOOR(S)	<input checked="" type="checkbox"/>	<input type="checkbox"/>	<input type="checkbox"/>	<input type="checkbox"/>	There were accessible doors that were visibly intact and functional.
8202 WINDOW(S)	<input checked="" type="checkbox"/>	<input type="checkbox"/>	<input type="checkbox"/>	<input type="checkbox"/>	There were accessible windows that were visibly intact and functional.
8203 VENTILATION	<input type="checkbox"/>	<input checked="" type="checkbox"/>	<input type="checkbox"/>	<input type="checkbox"/>	There were ventilation components that were visibly intact and functional, with exceptions. <u>[CR] There were ventilation components in bathroom(s) and/or laundry room that were dirty. This leads to moisture buildup and deterioration. These fans should be cleaned.</u> <u>[CR] There are vent terminations attached to the exterior of the home that were dirty and/or painted. This leads to moisture buildup and deterioration. These should be cleaned.</u> <u>[FE] There were bathrooms and laundry rooms/areas with no means of powered ventilation to the exterior. This can lead to moisture buildup and deterioration. There were windows that need to be manually operated but consideration should be given to having ventilation fans installed in these areas if moisture buildup is occurring.</u>

Dirty vent fan

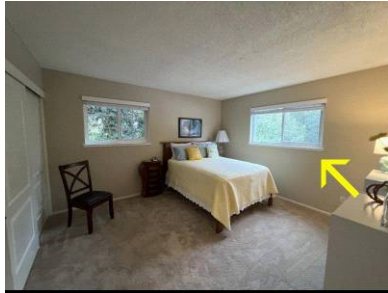
8205 EMERGENCY EGRESS	<input type="checkbox"/>	<input type="checkbox"/>	<input checked="" type="checkbox"/>	<input type="checkbox"/>	<u>[SC] There are sleeping room windows in this building that may have met the building standards at the time of construction but do not meet today's standards for emergency egress, due to the following conditions: There are windows that are too high above the floor [above the 44" from the floor], there are windows that are too small [less than 20 inches wide, less than 24 inches high and/or less than 5.7 square feet]. Upgrading the windows to the present standards is not required, but it is important that the residents be aware of the conditions stated. Placing climbable furniture in front of higher windows would be beneficial for emergency egress should the need arise.</u>
-----------------------	--------------------------	--------------------------	-------------------------------------	--------------------------	---

Windows are small & too high

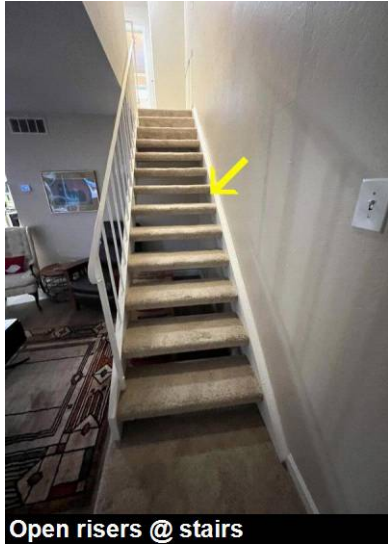
[SC] There are stairs with open risers more than 4 inches of space that are more than 30 inches above the floor/grade and is not adequate per accepted current standards. This condition is a safety hazard.

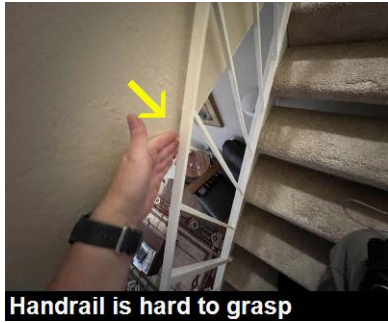
[SC] The handrail(s) are not considered to be graspable by today's standards. This condition is a safety hazard. We recommend upgrading the handrail(s) to meet today's standards for added safety.

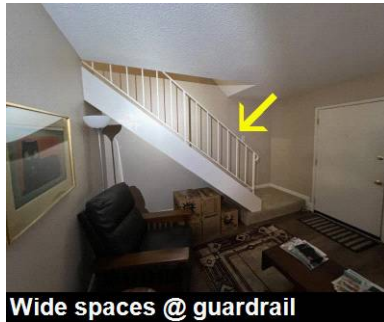
[SC] There are guardrail(s) that are less than 42 inches and not high enough to provide adequate protection against falling and did not meet the present standards.

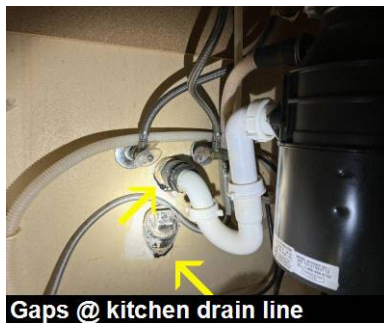
[CR] There were cabinets (sinks) with gaps, holes and/or unfinished wall sections in the wall and/or floor. These should be sealed to prevent pest, rodent and/or moisture intrusion.

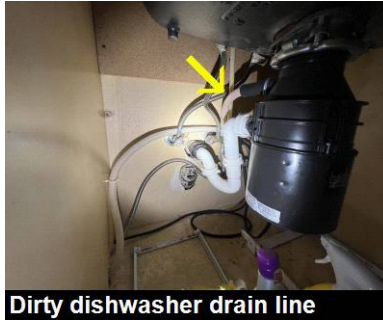
[SC] The dishwasher drain line is connected directly to the garbage disposal or drain line, the unit is missing the required visible air gap device (some units may have internal air gap devices but that can not be confirmed during a home inspection). This is a cross contamination/safety hazard.

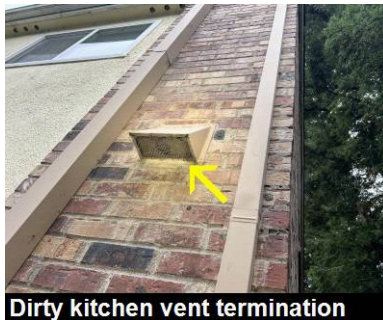
[SC] There are vent termination screens attached to the exterior of the home that were dirty. This leads to moisture buildup and deterioration as well as being a safety and fire hazard. These screens should be cleaned or repaired.

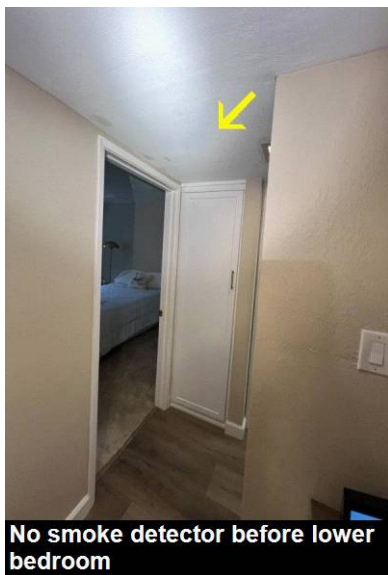
[SC] There are hallways without smoke detectors mounted before the beginning of bedroom doors and/or rooms without smoke detectors before bedroom doors. This is a safety hazard. Recommend checking with the manufacturers installation instructions and installing the smoke detector(s) as needed.

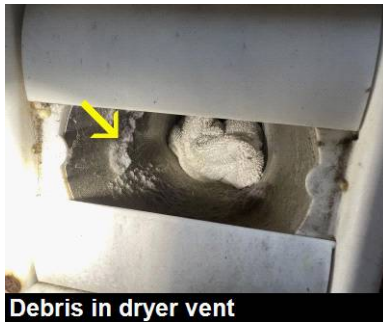
[SC] There are dryer vent hood(s) at the exterior wall has visible lint debris and/or the damper door is not functioning correctly, this is a fire hazard and should be corrected.

Debris in dryer vent
